London is soon going to lose one of its most familiar sounds when the world-famous Big Ben falls silent for repairs. The "bonging" chimes that have marked the passing of time for Londoners since 1859 will fall silent for months beginning in 2017 as part of a three-year £29m conservation project.

Instead, it is the Elizabeth Tower (1859) and the clock mechanism (1854), designed by Denison and Airy, that need attention.

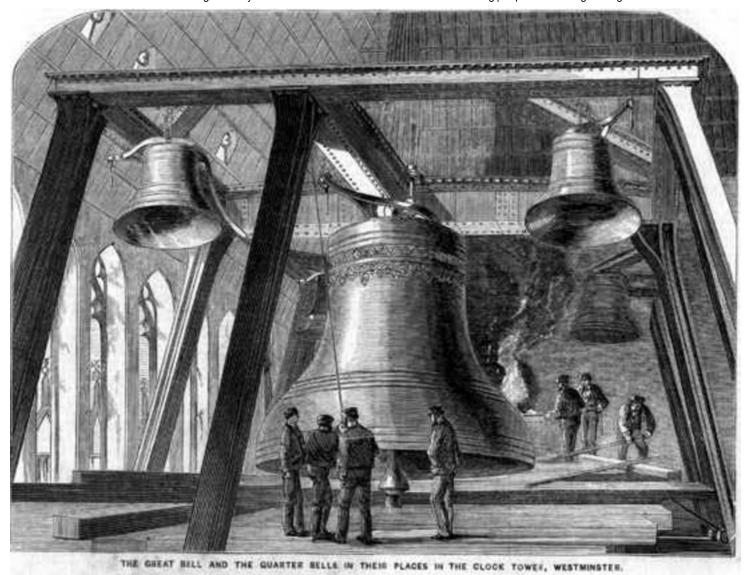
Big Ben in 1858. The Illustrated News of the World December 4 1858

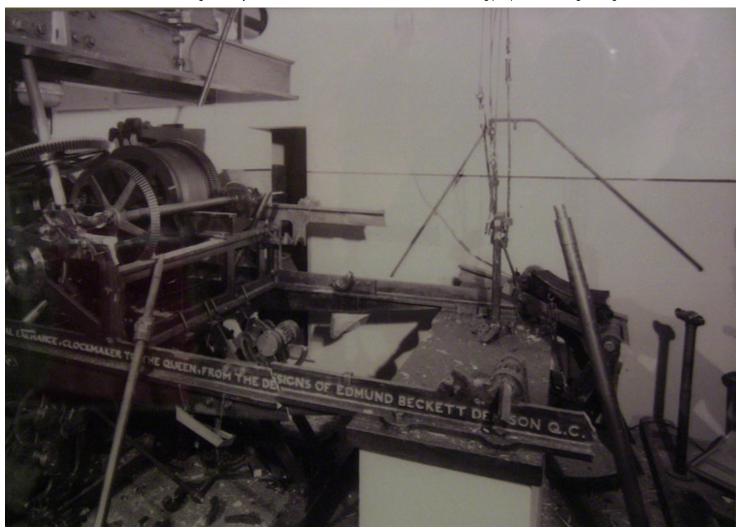
Big Ben's clock has had only one major breakdown, in 1976. UK Parliament, CC BY

The clock mechanism itself is remarkable. In its 162-year history it has only had one major breakdown. In 1976 the speed regulator for the chimes broke and the mechanism sped up to destruction. The resulting damage took months to repair.

The weights that drive the clock are, like the bells and hammers, unimaginably huge. The "drive train" that keeps the pendulum swinging and that turns the hands is driven by a weight of about 100kg. Two other weights that ring the bells are each over a tonne. If any of these weights falls out of control (as in the 1976 incident), they could do a lot of damage.
